CITY OF LAGO VISTA

WASTEWATER
MASTER PLAN

WASTEWATER MASTER PLAN

City of Lago Vista

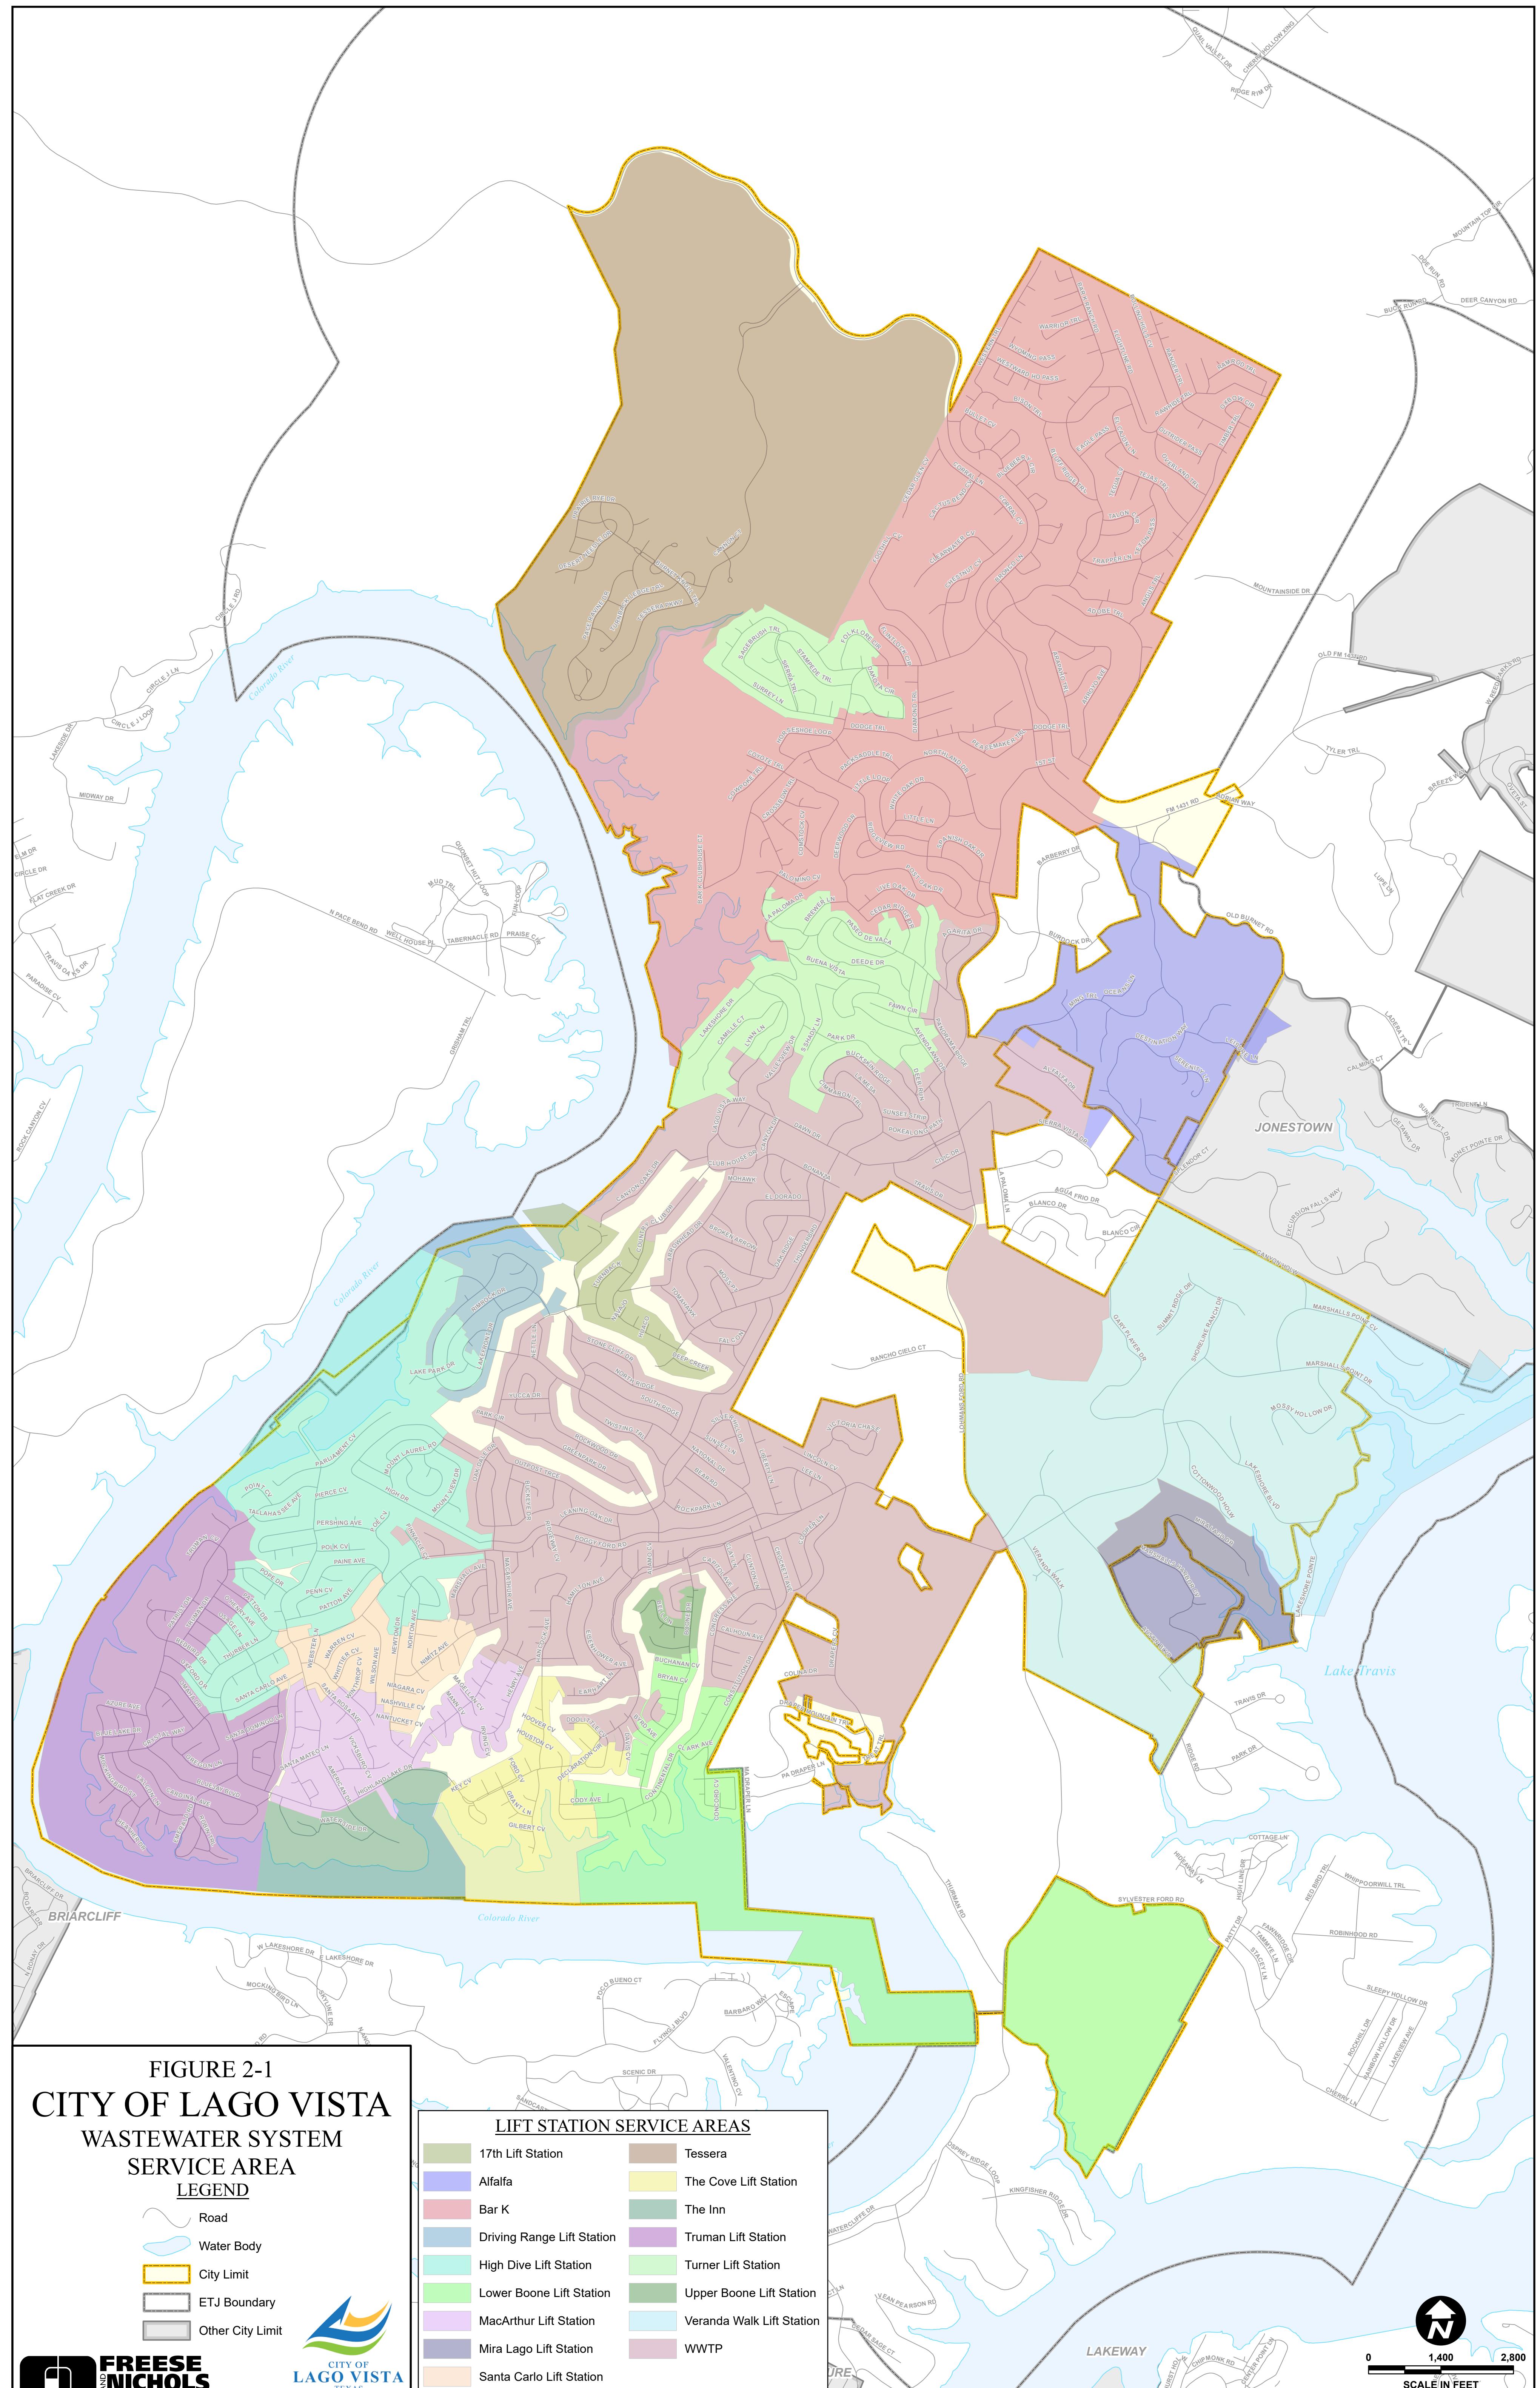
In addition to service provided within its CCN boundaries, Lago Vista provides wastewater wholesale service to The Hollows Subdivision in Jonestown, Texas. **Figure 2-1** illustrates the wastewater service area evaluated as part of the Wastewater Master Plan.

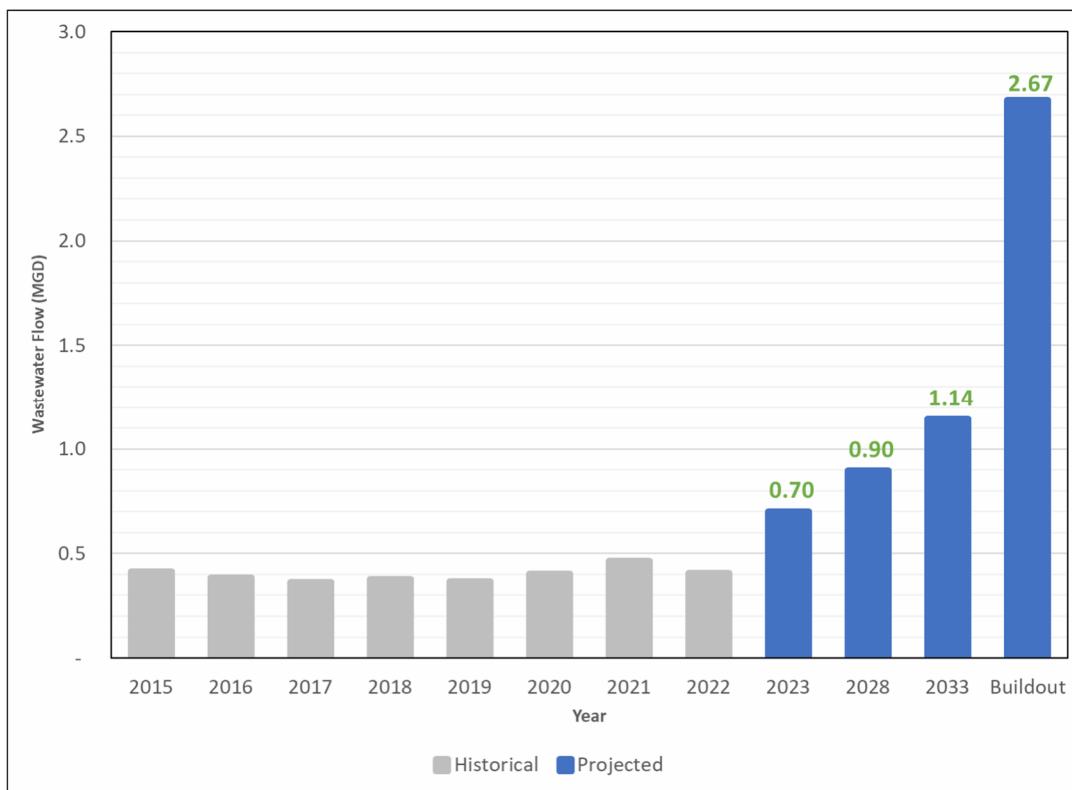
Figure 3-1. Historical and Projected Average Day Wastewater Flow

Average day wastewater flows were projected for the existing, 2028, 2033, and buildout planning scenarios by applying an average, per-connection flow to the additional wastewater connections. The future per-connection wastewater flows were assumed to remain the same as the established average per-connection wastewater flows. Recent data points to a stagnating trend of daily average treatment volumes, resulting in a decreasing per-connection production of wastewater. Despite the low wastewater production in 2019 and 2020, for the purposes of this analysis, it was assumed that these reduced volumes may not be representative of likely future discharge patterns. Consequently, a conservative average discharge rate of 135 gallons per connection per day was assigned for future year projections. The resulting wastewater flow projections compared with historical flows seen at the wastewater treatment plant are summarized in **Figure 3-1**. Even though area within the City's ETJ was not considered for sizing of infrastructure in this Master Plan, it is important to note the potential impact to the ultimate sizing of the City's existing wastewater treatment plant. Based on the projected wastewater flow per connection and the projected growth within the ETJ of 13,396 connections, the City would receive an additional 1.81 MGD of average day dry weather flow.

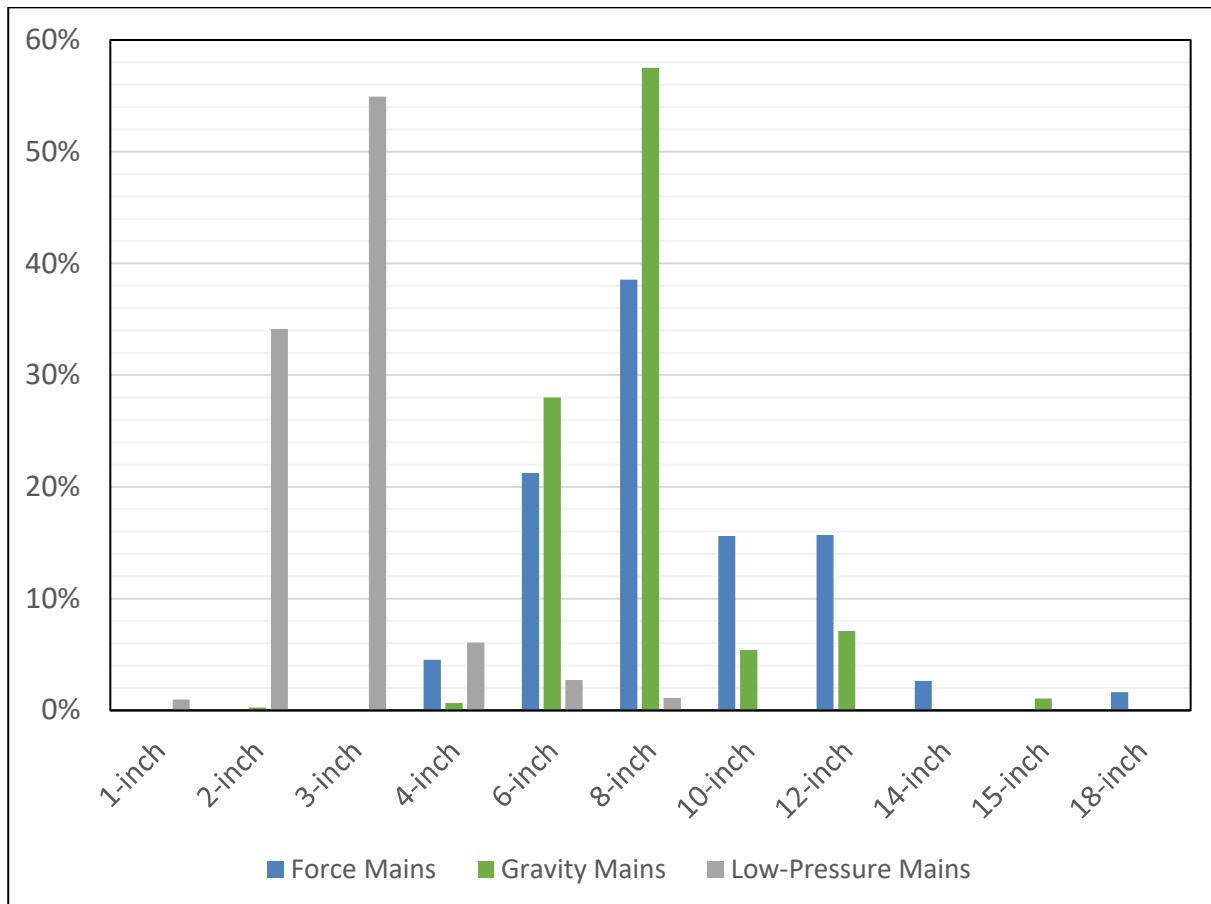
Figure 4-1 Pipeline Diameter by Length and Main Type

The existing wastewater system consists of a total of 124 miles of sewer pipe. Pipeline diameters range in size from 1-inch to 10-inches for pressure pipes, 2-inches to 15-inches for gravity pipes, and 3-inches to 18-inches for force mains. **Figure 4-1** illustrates the percentage of pipe length by diameter and main type.

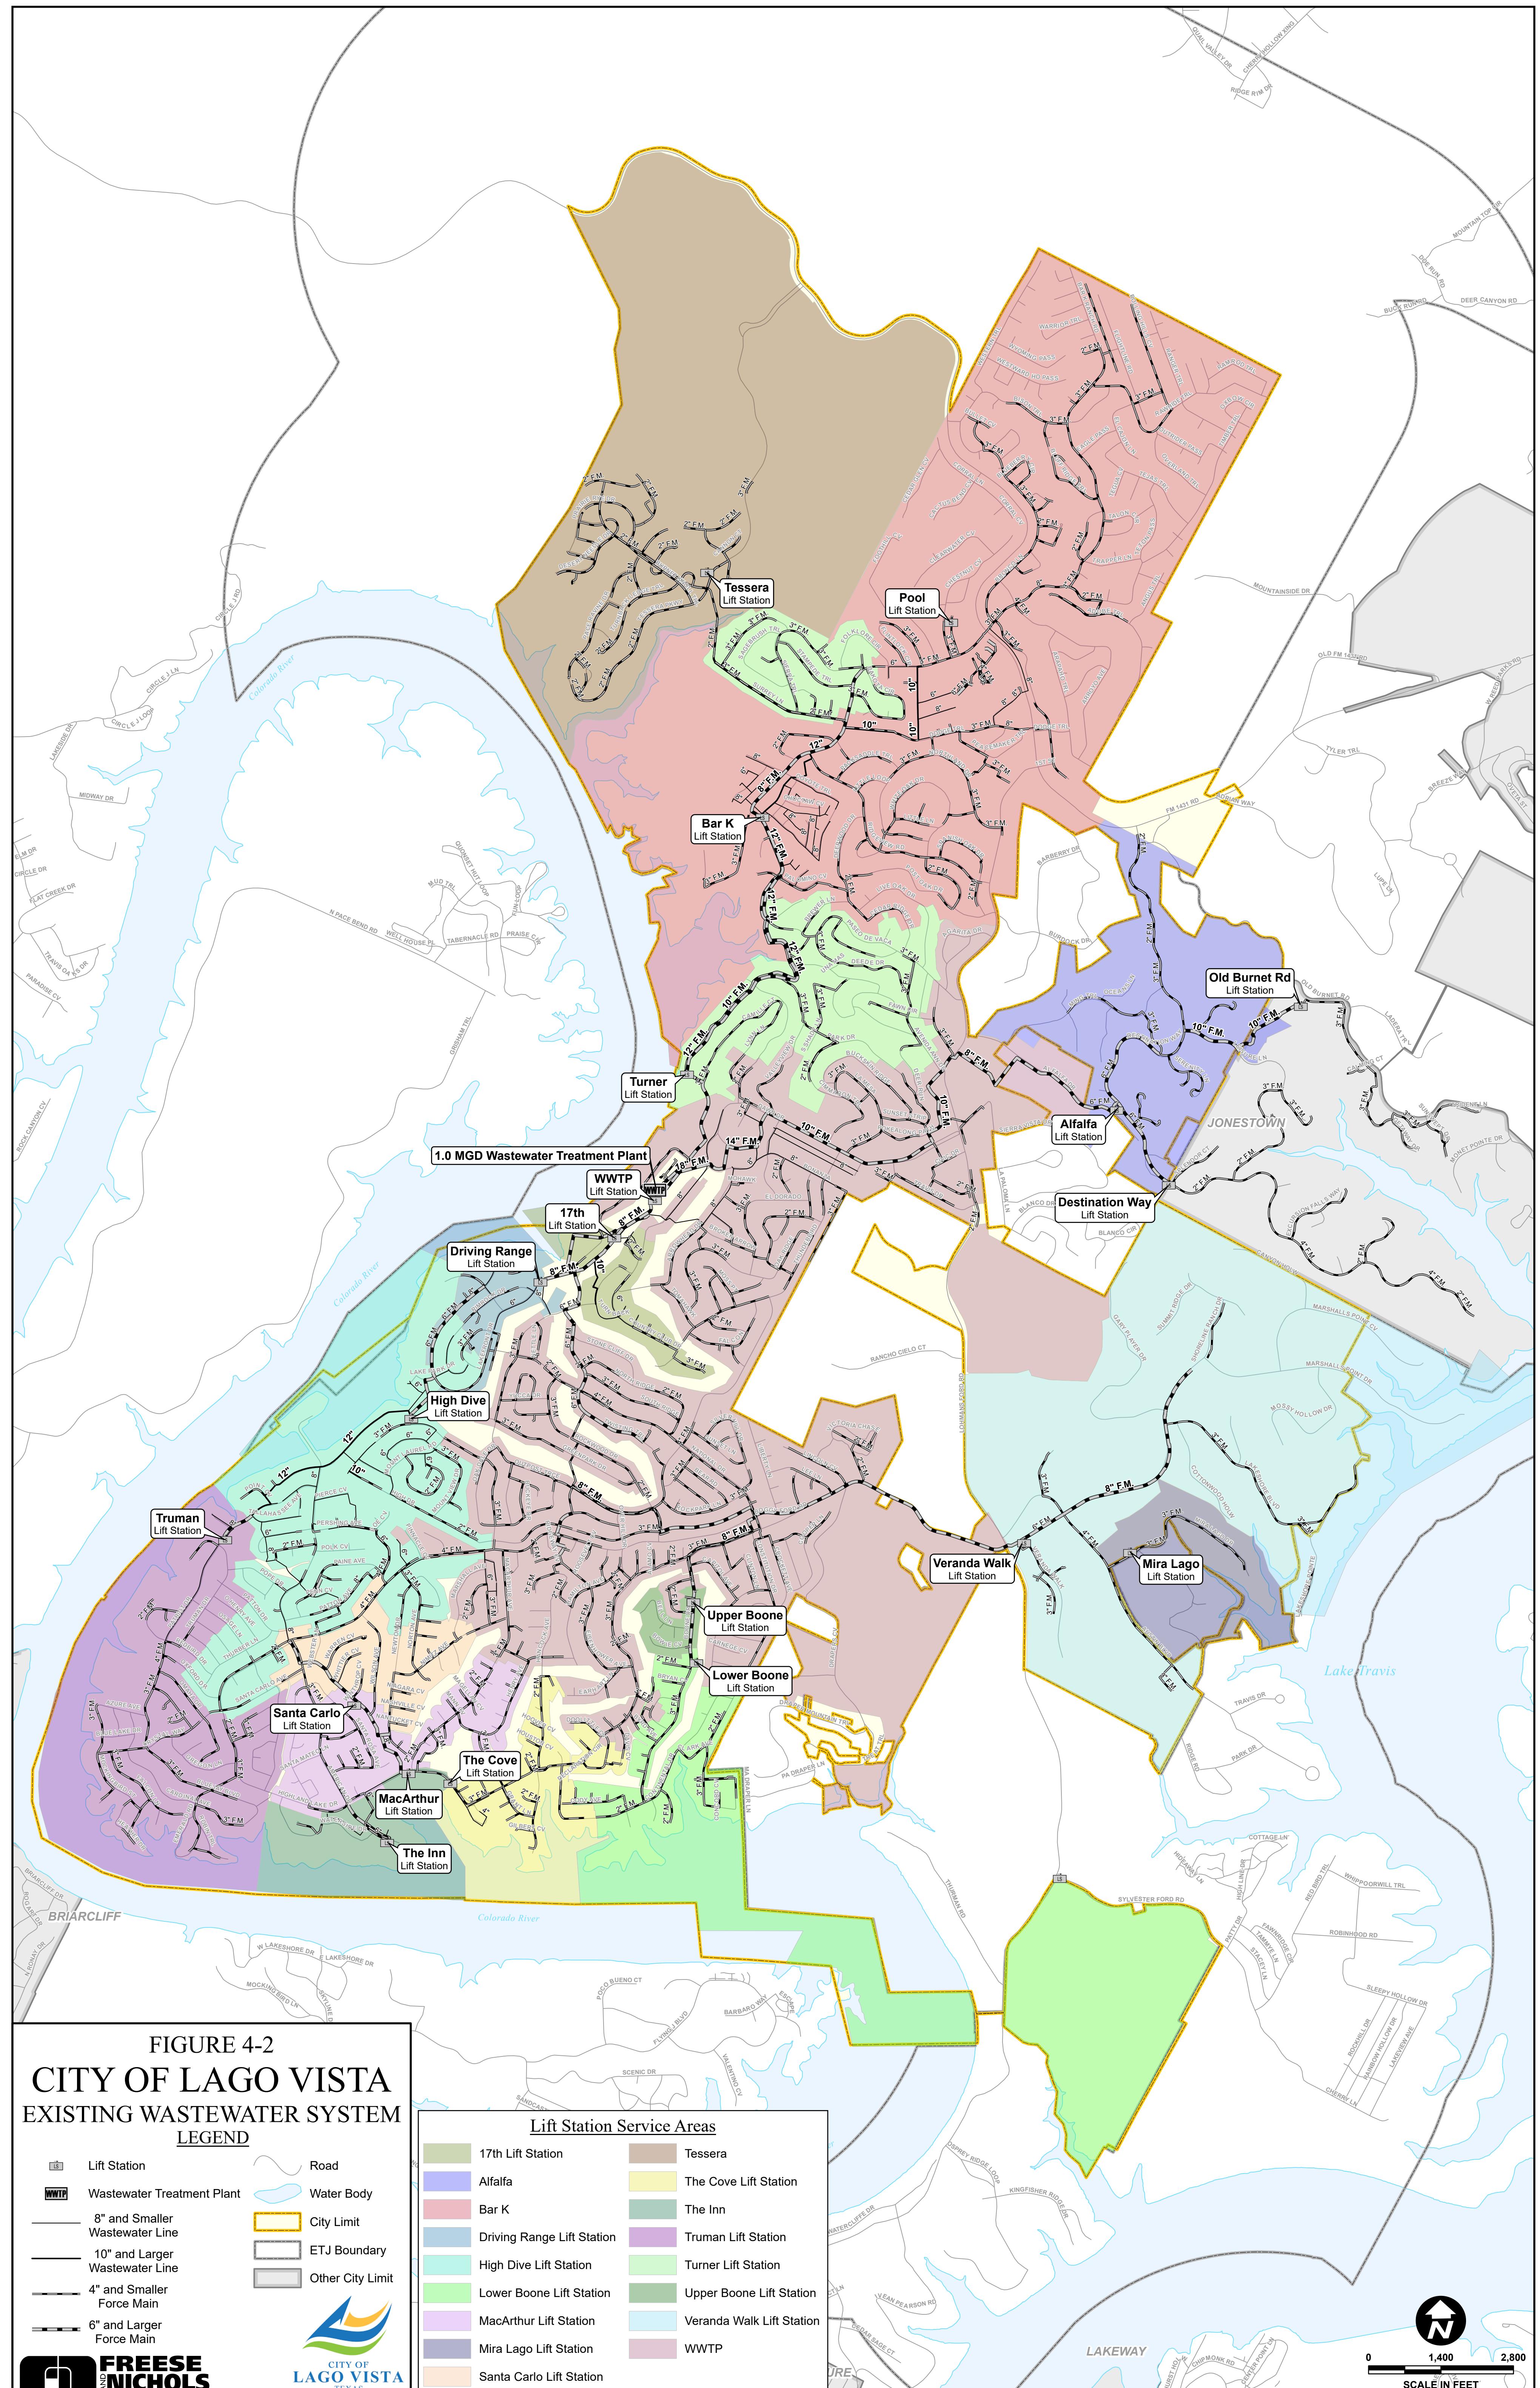
FIGURE 4-2

CITY OF LAGO VISTA EXISTING WASTEWATER SYSTEM LEGEND

The existing wastewater collection system consists of 91 miles of low-pressure sewer mains, 18 miles of wastewater gravity mains, 20 lift stations and 15 miles of associated force mains, and one wastewater treatment plant. **Figure 4-2** illustrates the existing wastewater collection system.

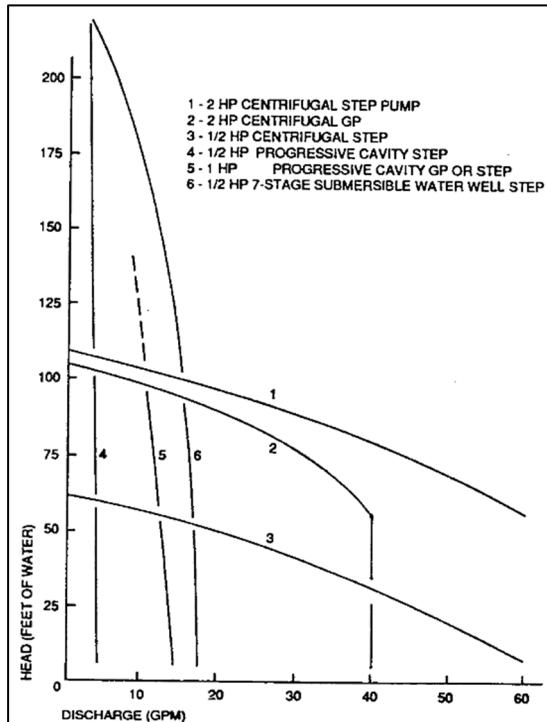
Figure 4-3. Head-Discharge Curves for Typical GP and STEP Systems

Progressive cavity pumps typically require motors sized between 1 to 1½ hp and produce consistent discharge flow rates across a wide spectrum of head ranges (i.e., the pump curve is steep). Progressive cavity pumps work well in systems with a wide range of head conditions because the flow rate is consistent regardless of the fluctuating head condition in the system. For this reason, progressive cavity pumps are not selected by engineers when designing lift stations with their own dedicated force main system and the head condition is known and static. The highlighted use of progressive cavity pumps is in systems with varying head conditions. Whether the condition is high head or low head, the pump discharges flow in a tight and consistent range. An example of progressive cavity and centrifugal pump curves is illustrated in

Figure 4-3.

Centrifugal pumps, commonly used in lift stations with dedicated force mains, are selected when the head and flow condition for the force main system is well-defined and unaffected by competing pumps. Force main systems are typically a closed system with only one active facility in operation to create a localized peak hydraulic gradient. For this reason, the pump can be designed with a flatter curve in which the optimal design point for its operation corresponds with the design headloss condition created by the force main and the desired flow rate. In systems with multiple centrifugal pumps, like multiple lift stations pumping to a common force main, varying head conditions within the force main network will cause the pumps to operate to the left of its curve (high head, low flow) as more pumps turn on and pressure builds in the force main, and to the right of its curve (low head, high flow) when fewer pumps are on and pressure in the force main is lower. The difference in flow output from the left side of the pump curve where a pump's flow rate can be reduced to a point where the outflow is less than the inflow can cause the water level in the upstream storage tank to rise to a point of overflow. On the other end, when a pump operates

too far to the right on its curve and doesn't have the downstream restriction needed for its proper operation, the pump can overheat and burn out. Varying operation conditions (no pumps on to many pumps on) with high topographical variation in a common force main network results in centrifugal pumps to operate on every part of its curve that results in times in which high amounts of flow are produced and times in which low amounts of flow are produced.

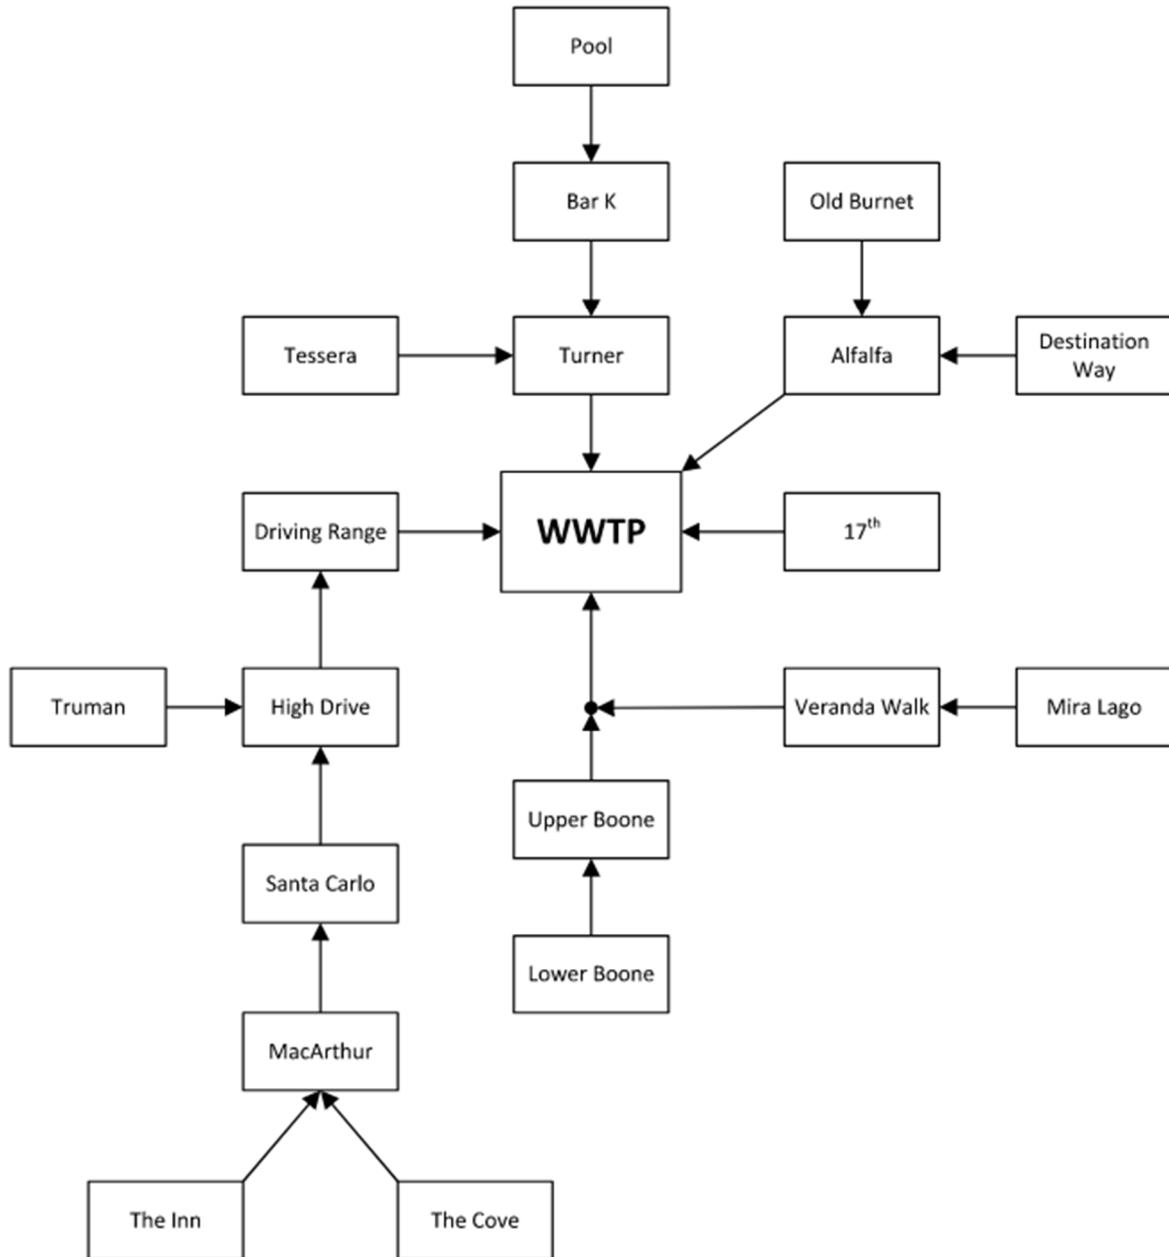
Figure 4-5. Lift Station Hierarchy

Lift stations are necessary where wastewater must be pumped to a higher elevation or where there is insufficient grade to convey flow entirely by gravity. Because of the topographical change across the City's wastewater service area, Lago Vista operates 20 lift stations throughout the service area. The lift stations vary in size from small lift stations that serve a public pool to the three primary regional lift stations that serve as the collection point before sending flow to the WWTP. The hierarchy of lift stations is illustrated in **Figure 4-5**. 17th, Driving Range, and Turner LS pump roughly a third each of the total daily flow to the WWTP and are crucial facilities in the wastewater system. The City provided an inventory of pump manufacturer information for active lift stations, where available. This information was used, in coordination with the pump manufacturer, to obtain the pump curves and estimate the flow with the largest pump out of service (i.e., the "firm capacity"). For duplex lift stations, the one-pump flow is the firm capacity. The summation of individual pump capacities for each lift station presented in **Table 4-2** as the *Existing Total Capacity* should not be interpreted as the actual total capacity with all pumps running. Multiple pumps operating simultaneously do not have a totalized output equal to the sum of rated capacity of each pump operating alone because the additional flow generated by multiple pumps discharging into a common force main increases head loss, and pump output decreases the higher the head it must pump against. A field draw down test would be required to understand the field rating for a given lift station.

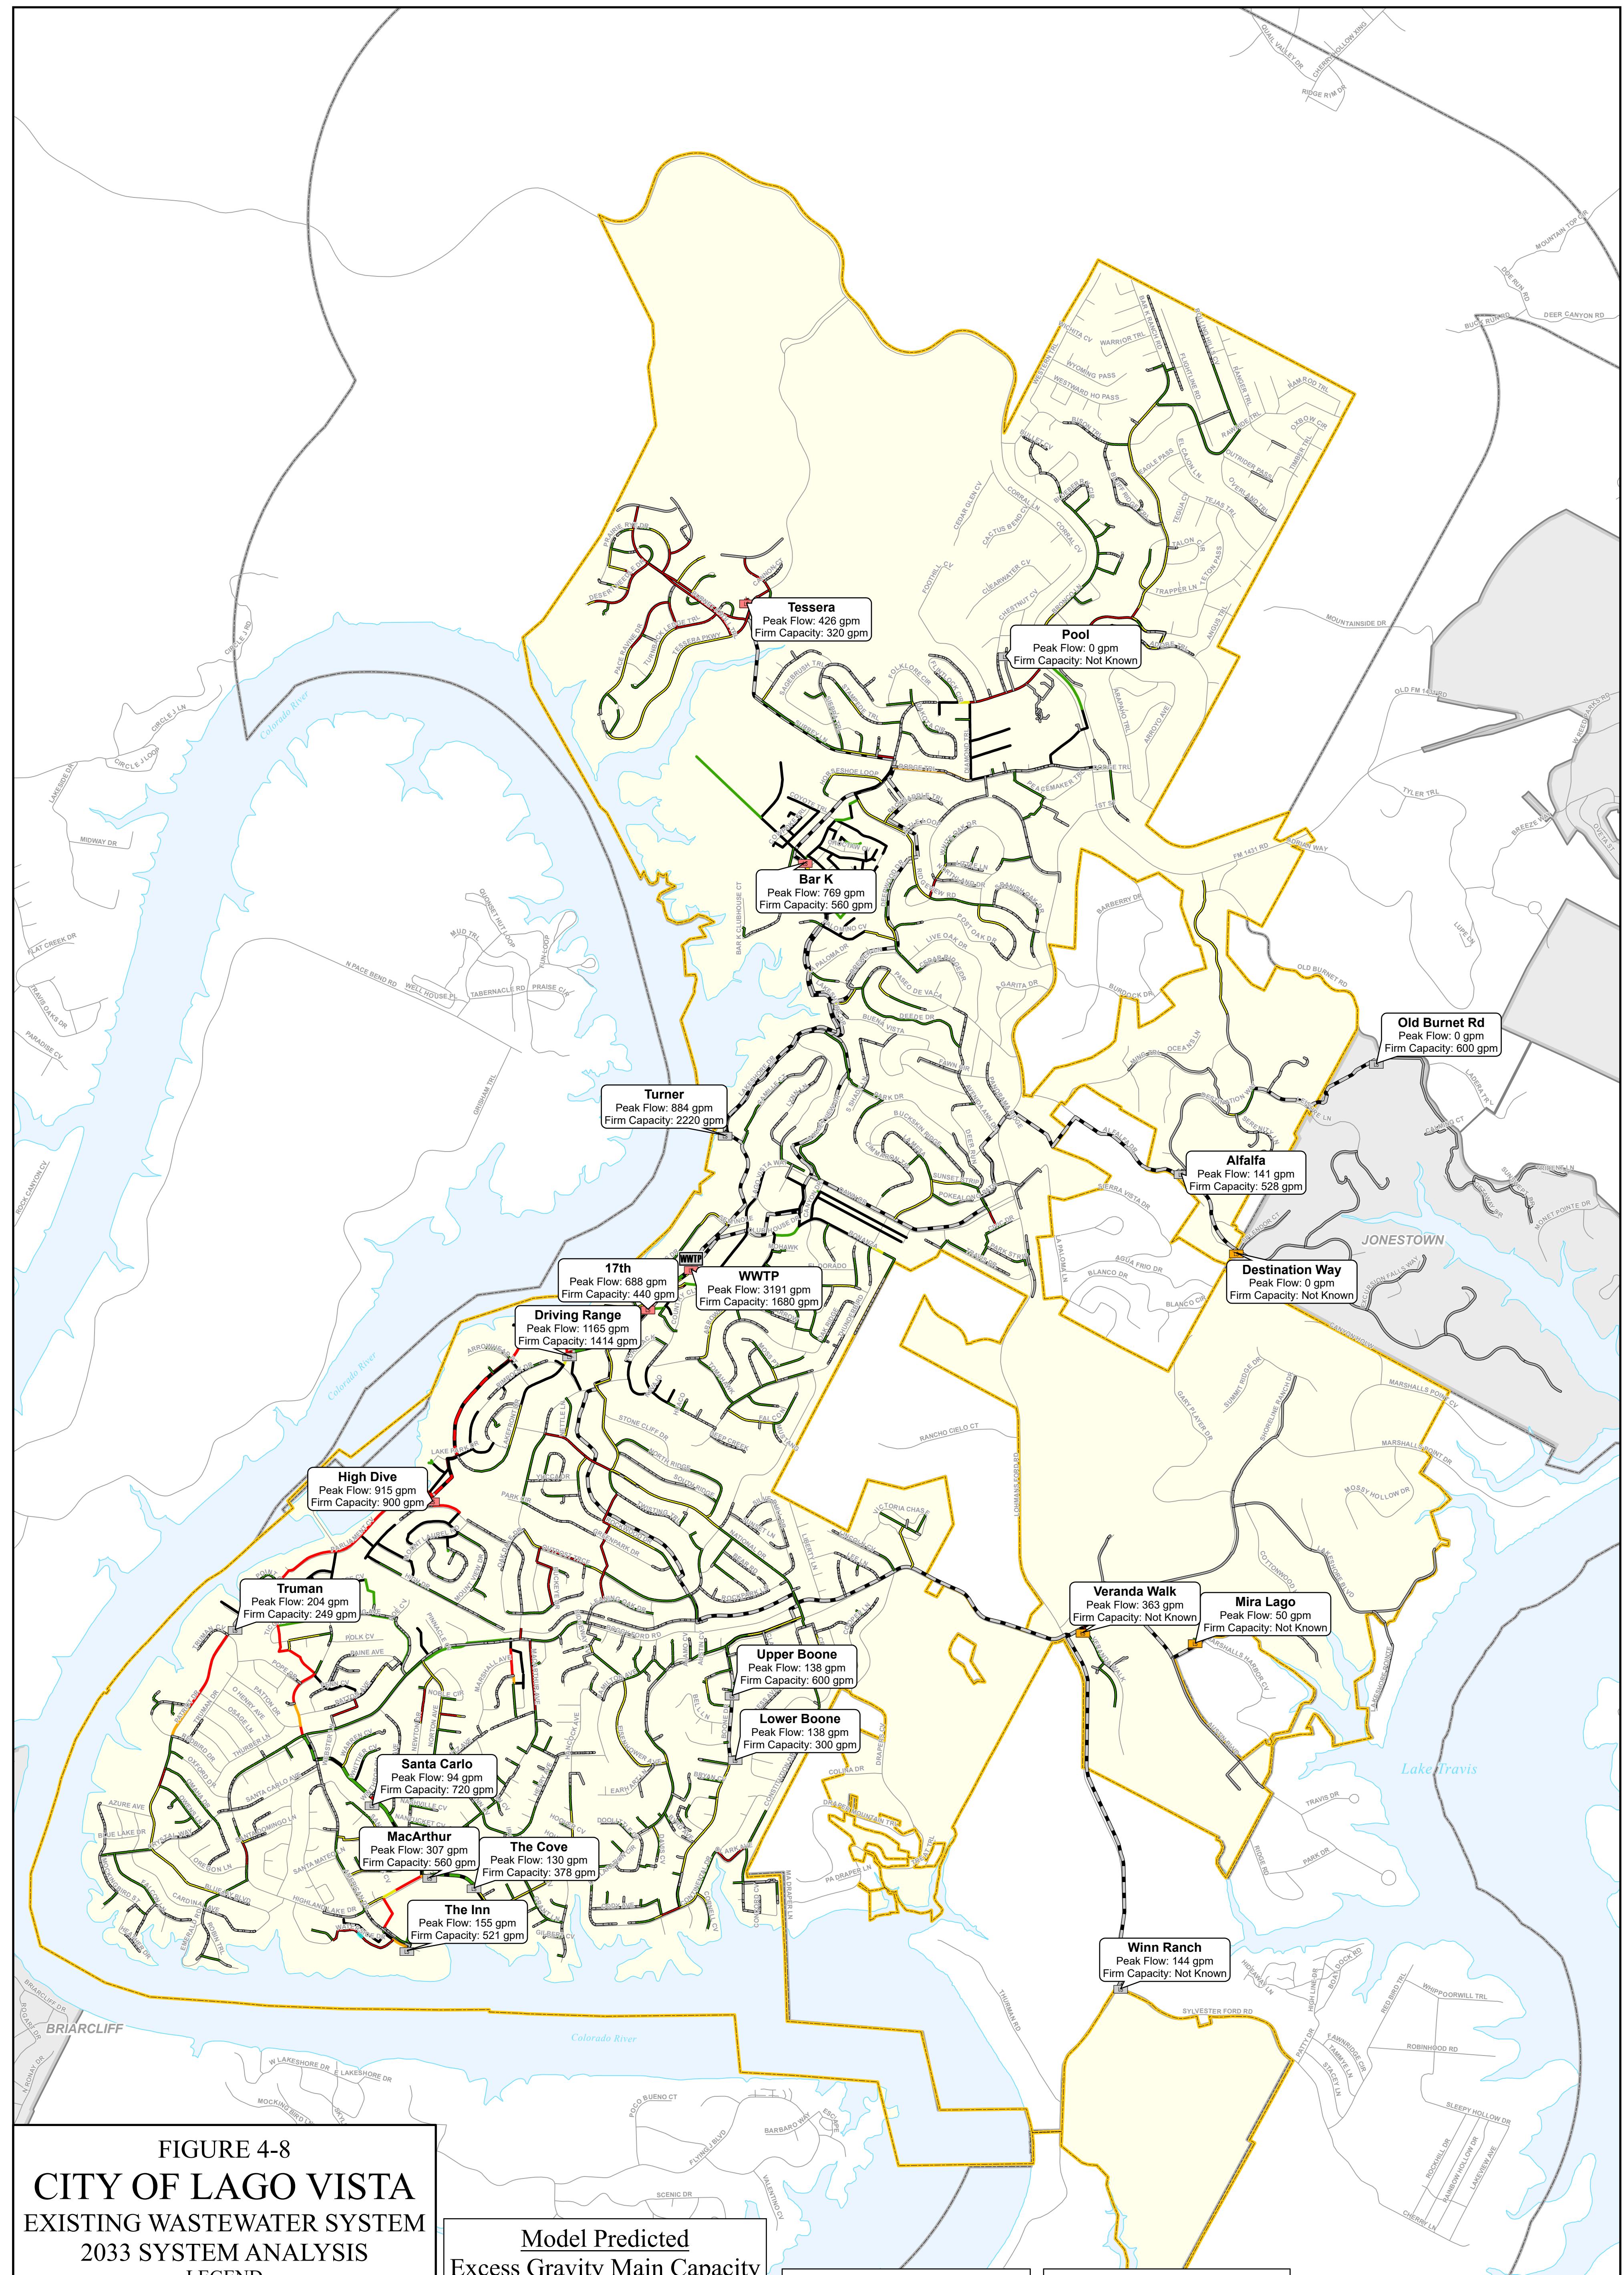
FIGURE 4-8
CITY OF LAGO VISTA
EXISTING WASTEWATER SYSTEM
2033 SYSTEM ANALYSIS

To serve the future growth, Lago Vista must rehabilitate, replace, or upsize existing infrastructure and provide additional service to areas of growth where little or no infrastructure currently exists. The existing wastewater system was evaluated at the 2028, 2033, and buildout planning scenarios to determine the effects of future growth. **Figure 4-6**, **Figure 4-7**, **Figure 4-8**, and **Figure 4-9** illustrate the existing system

and its response to a maximum pump-on scenario with future planning year flows. Predicted overflows in the existing system are worsened by projected growth, particularly in the southernmost part of the collection system. Growth upstream of LS-9 requires additional capacity in the gravity main and at LS-9 itself. The effects of increasing the pumping capacity of LS-9 will require upsizing the already-constrained gravity main between LS-9 and LS-7. Growth in the western part of the system will result in flows exceeding the capacity of lift stations, but merely increasing pumping capacity will result in excessive force main velocities (7.0 ft/s or higher). Gravity main solutions in the western part of the service area, where possible, will need to be studied as an alternative to upsizing lift stations and manifold force mains to eliminate the complications of operating a manifold force main system. Wastewater system capital improvement projects were developed to accommodate anticipated growth through the 2040 planning year and resolve capacity deficiencies projected to occur in the future system analysis.

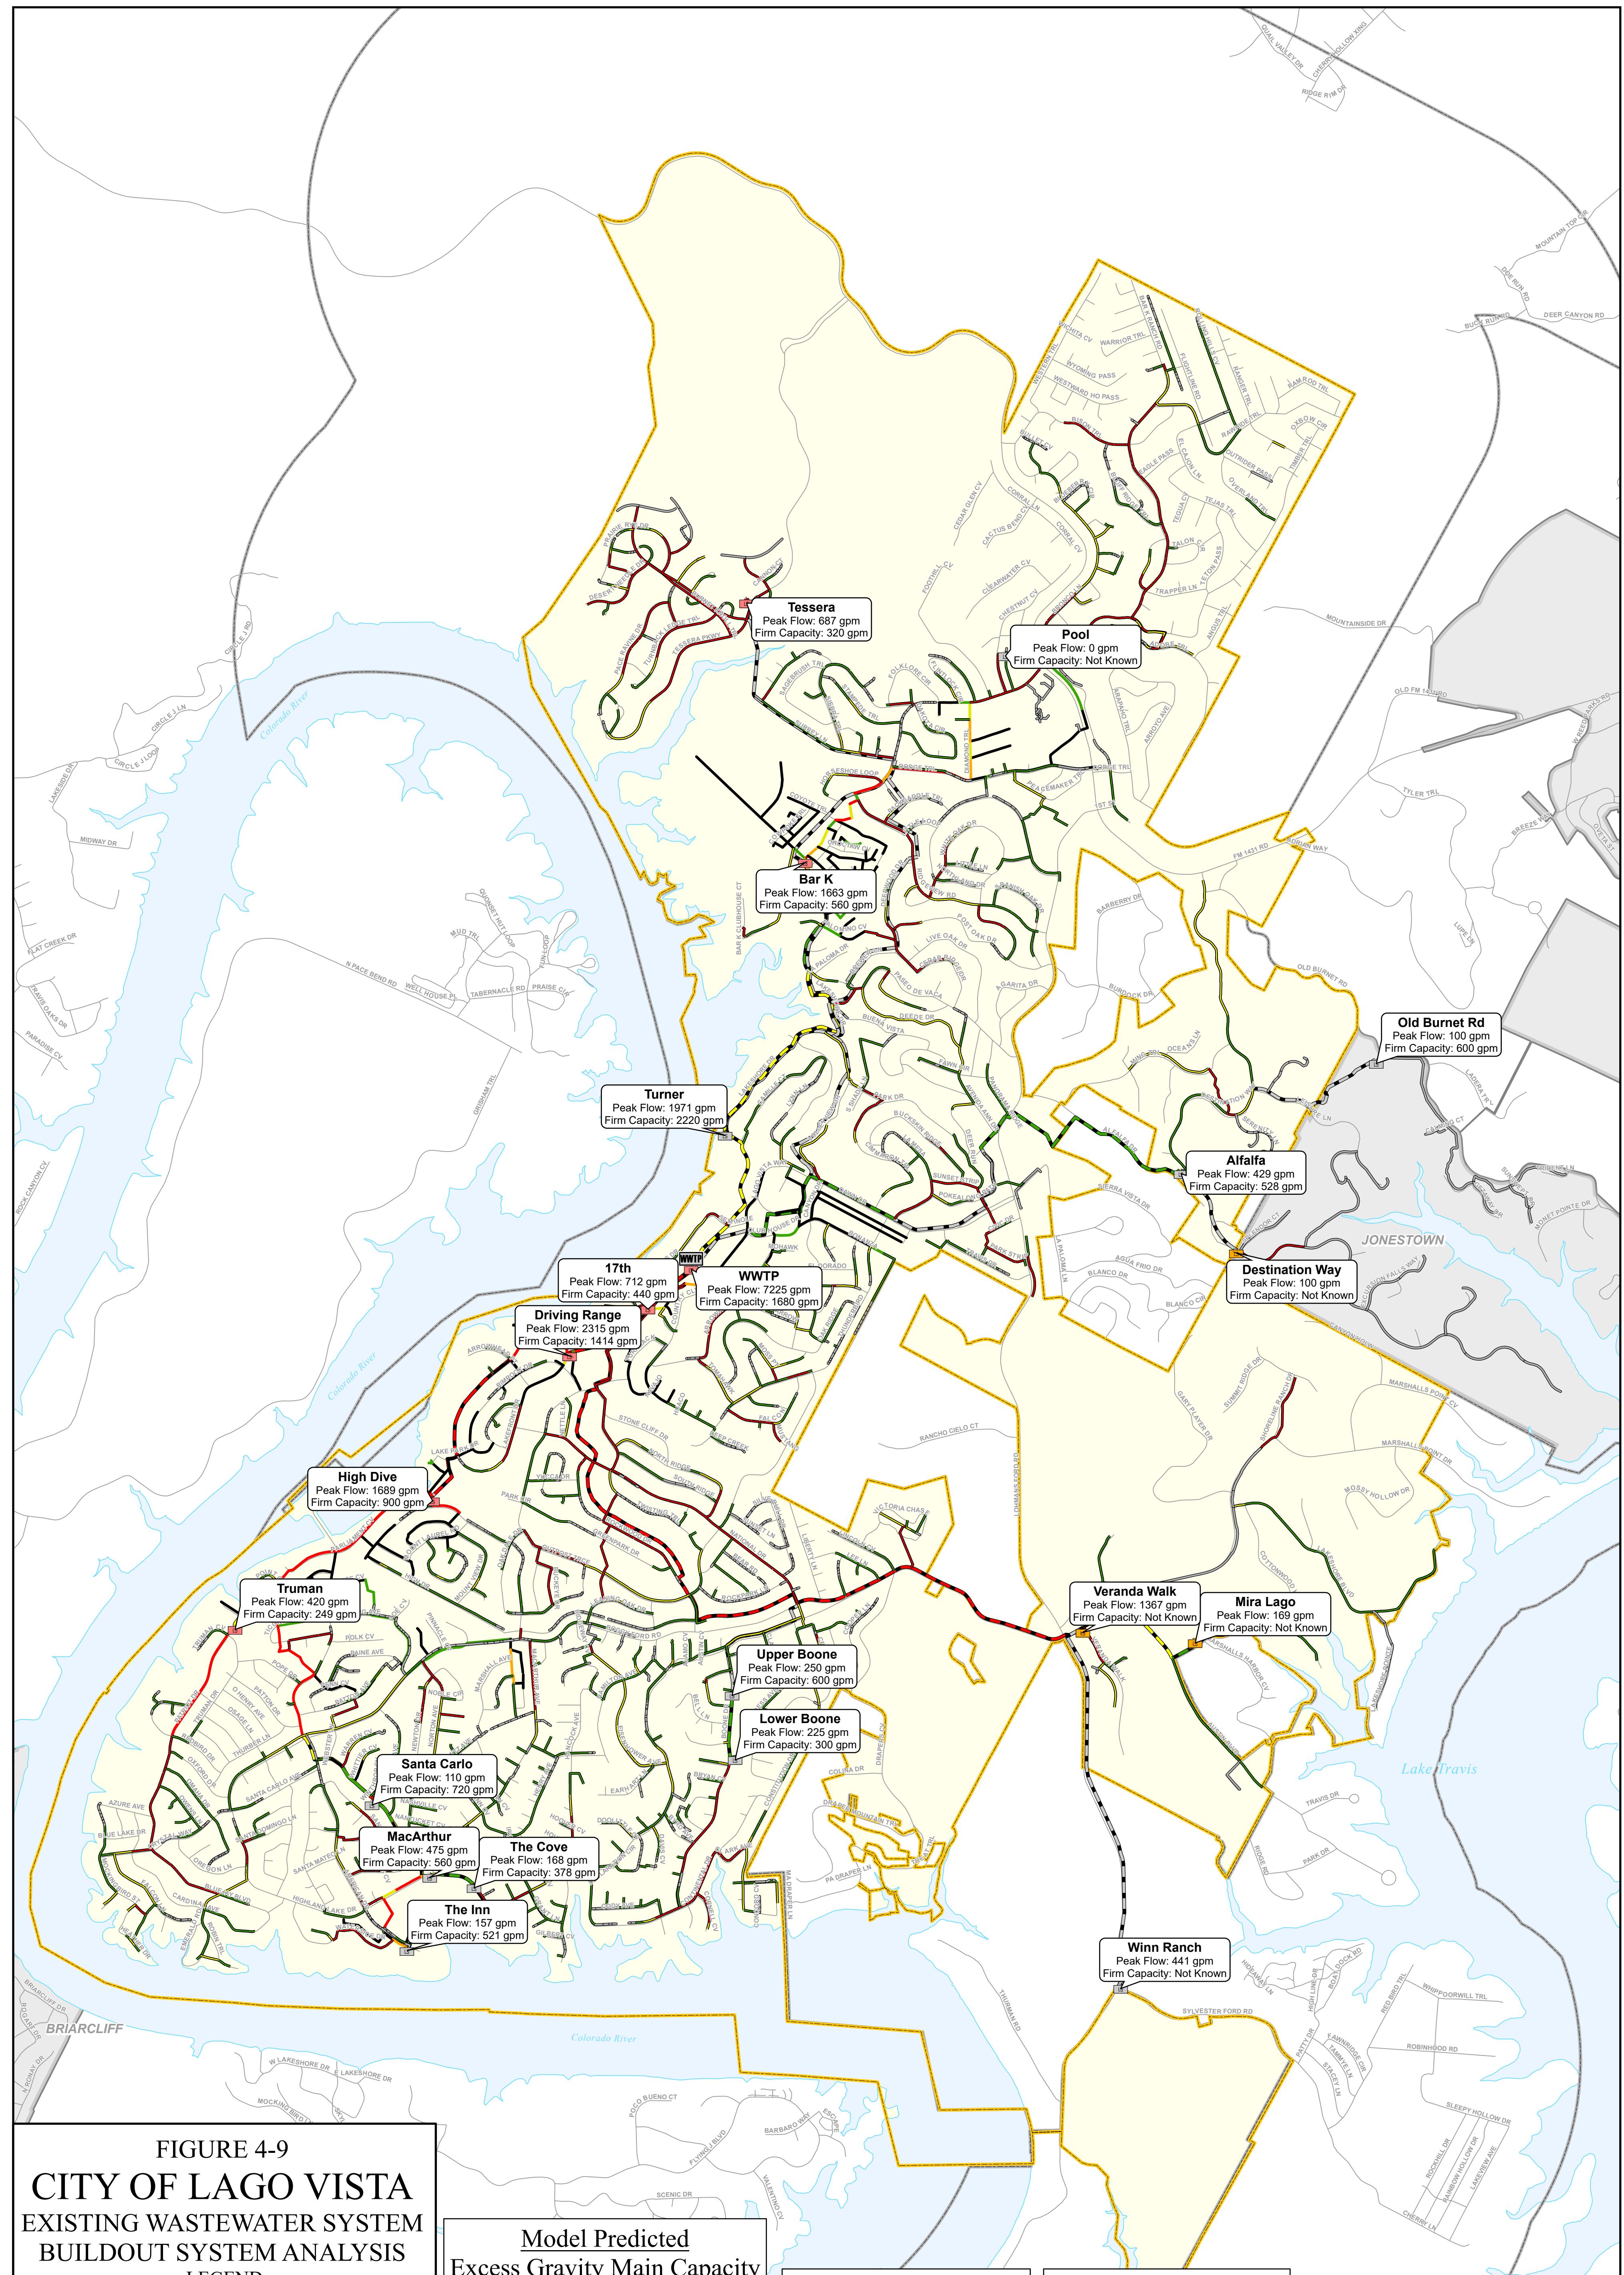
FIGURE 4-9
CITY OF LAGO VISTA
EXISTING WASTEWATER SYSTEM
BUILDOUT SYSTEM ANALYSIS

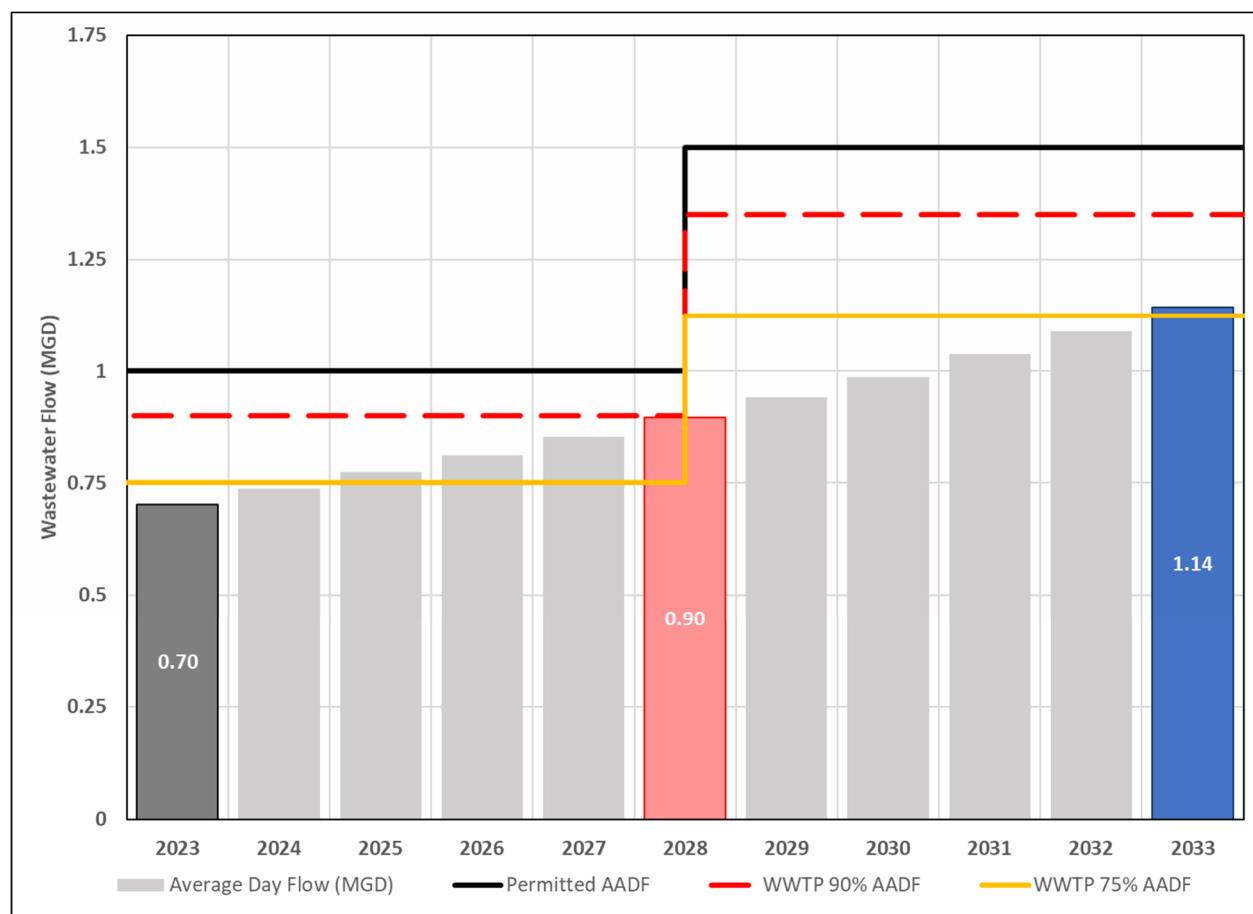
Figure 4-10. Projected Average Day Flow into the WWTP

Based on the growth projections described in **Section 2** and the projected wastewater flows described in **Section 3**, Lago Vista will have adequate WWTP capacity through the 2028 planning scenario assuming all flow continues to be conveyed to the existing plant. Around the 2027-2028 time period, the WWTP influent flow is projected to exceed the 75% rule that stipulates improvements to the WWTP must be in-design to accommodate future flows. Improvements to increase the WWTP's ability to treat up to 1.5 MGD on an annualized average daily flow basis would provide the buffer beyond the 2033 planning year. As the wastewater collection system continues to grow and receive more wastewater, the wastewater treatment plant will ultimately need to be able to treat 2.57 MGD of annualized average daily flow at system buildout. **Figure 4-10** illustrates the projected flows into the WWTP for the next 10 years.

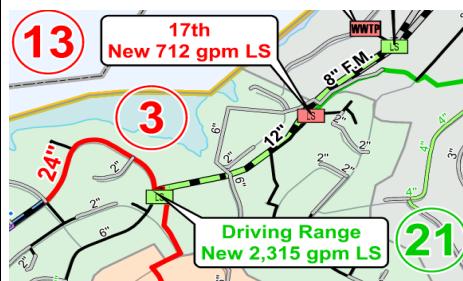
Vicinity Map

This project includes a 24-inch gravity sewer line beginning at Arrowhead Point and ending at the existing Driving Range LS.

The proposed gravity main is needed to relieve existing capacity deficiencies as determined by the existing system analysis. The existing 8-inch has significant grade, however the main undersized to receive flow from High Drive LS and has a history of sanitary sewer overflows along Lakefront Drive. This main will be sized to accommodate buildout flows from Growth Zone 1 as well as some flows redirected from Growth Zone 2.
