CITY OF LAGO VISTA

WASTEWATER
MASTER PLAN

WASTEWATER MASTER PLAN

City of Lago Vista

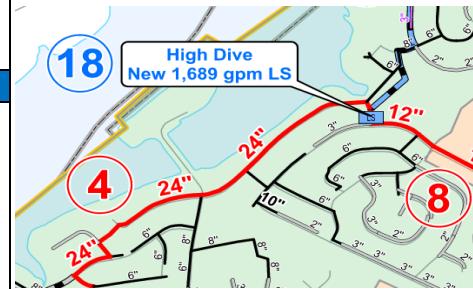
Vicinity Map

This project consists of a 24-inch gravity sewer line to replace an existing 12-inch sewer along Parliament Cove, ending at the existing High Drive LS.

The existing 12-inch sewer main along Parliament Cove has a history of sanitary sewer overflows. The overflows are due in part to the sewer main being undersized and also in part to a low-lying manhole. The increased size of sewer main will increase the conveyance capacity in the pipe and relieve the area of localized capacity constraints identified in the existing system analysis. This project will be sized for buildout flows in Growth Zone 1.

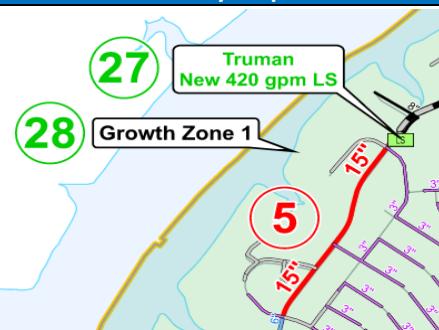
Vicinity Map

The proposed gravity main relieves existing capacity deficiencies, as determined by the existing system analysis, and is sized to accommodate buildout flows from part of Growth Zone 1.

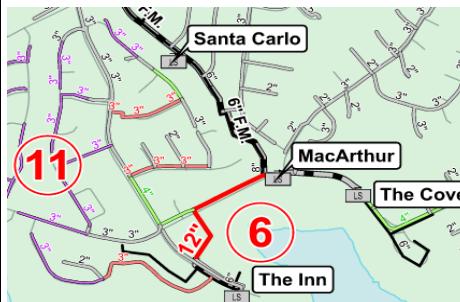
Vicinity Map

This project includes a 12-inch gravity sewer line that receives flow from The Inn LS and directs flow to the MacArthur LS.

The proposed gravity main increases the conveyance capacity to MacArthur LS and relieves existing capacity deficiencies, as determined by the existing system analysis. The existing 10-inch and 6-inch gravity main on Highland Lake Drive are low lying, with little excess ground cover. As such, the risk of sanitary sewer overflows are high in the event of minor surcharge. Sewer flow can be contained within the pipe if the pipe size is increased.

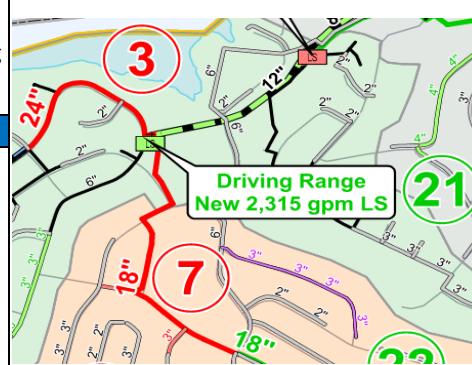
Vicinity Map

This project includes an 18-inch gravity sewer line beginning at Twisting Trail and National Drive and ending at the existing Driving Range LS.

The proposed gravity main is needed to relieve existing capacity deficiencies in the low-pressure sewer mains along Twisting Trail as determined by the existing system analysis. This main will be sized to accommodate buildup flows from part of Growth Zone 2 and all of Growth Zone 4 to be serviced by a future extension of the 18-inch sewer line along National Drive (Project #22).

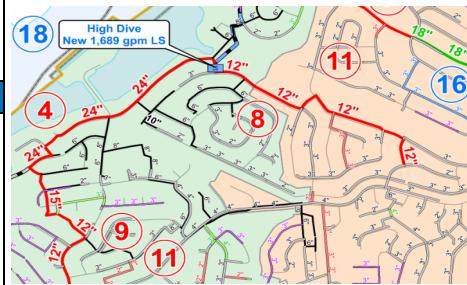
Vicinity Map

This project includes a 12-inch gravity sewer line beginning at Outpost Trace and Oak Dale Drive and ending at the existing High Drive LS.

The proposed gravity main redirects flow to relieve existing capacity deficiencies in the downstream low-pressure sewer mains as determined by the existing system analysis. This main will be sized to accommodate buildout flows from part of Growth Zone 2.

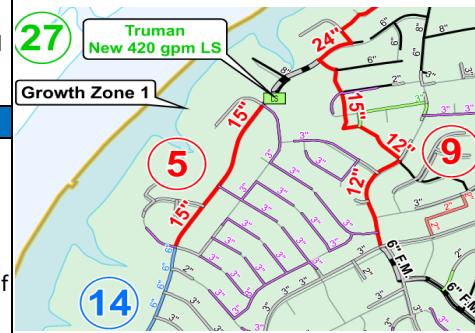
Vicinity Map

This project includes segments of 15-inch and 12-inch gravity sewer lines beginning at American Drive and Boggy Ford Road and ending at the upstream end of Project #4.

The proposed gravity mains receive flow from the buildup of the lower portion of Growth Zone 1. The need for this project was determined from the existing system analysis and will be sized for buildup flows. This project is dependent upon the construction of Project #4.

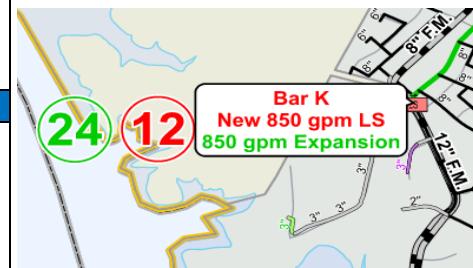
Vicinity Map

This project includes a new wet well at the existing Bar K location and improves the pumping capacity to 850 gpm. Additional capacity is required to accommodate future flows.

This project is intended to increase the pumping capacity to accommodate growth in Growth Zones 6, 7 and 8.

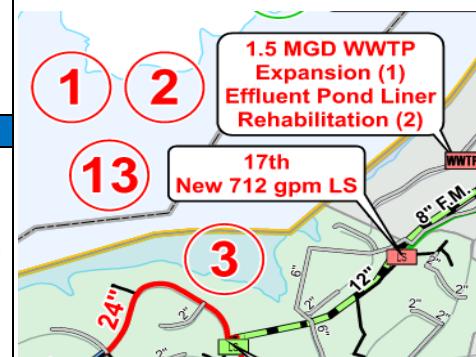
Vicinity Map

This project includes a new wet well at the existing 17th hole lift station location and improves the pumping capacity to 712 gpm.

Additional capacity is required to accommodate future flows. This project is dependent upon growth in Growth Zone 6.

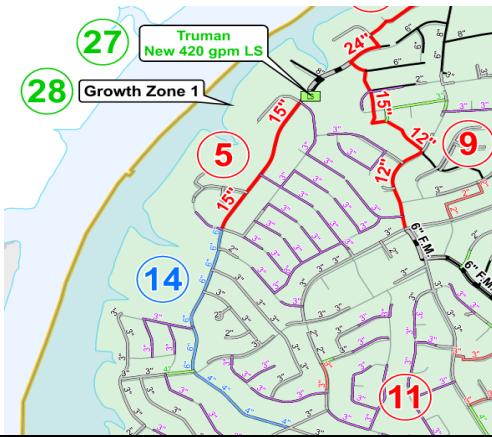
Vicinity Map

The proposed pressure main accommodates buildout flows as a result from growth in Growth Zone 1. A gravity main could not be installed in place of the proposed pressure main due to the ground topography.

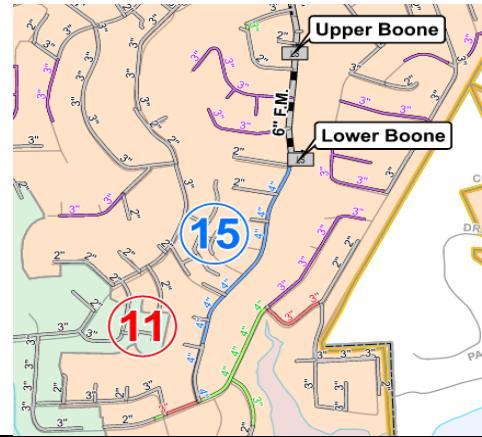
The proposed pressure main accommodates buildout flows in the Lower Boone LS service area. A gravity main could not be installed in place of the proposed pressure main due to the ground topography.

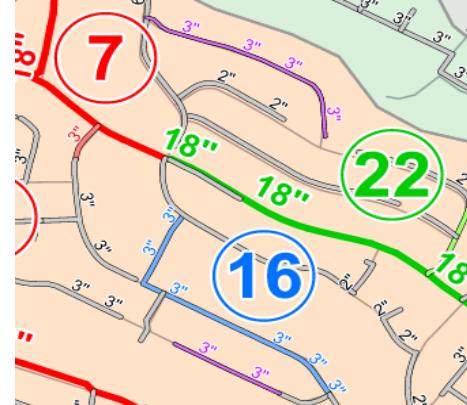
The proposed pressure main accommodates buildout flows in the Lower Boone LS service area.

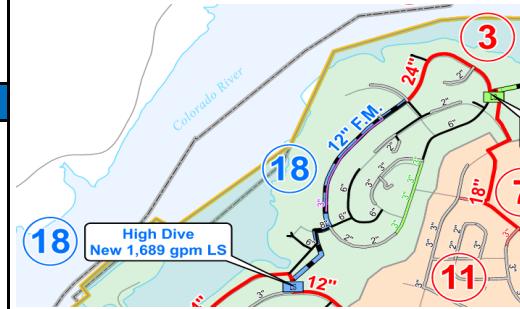
This project includes a new lift station at the existing High Drive LS location to improve the pumping capacity to 1,689 gpm and replace the existing force main with a 12-inch force main.

The design flow rate will accommodate projected buildout flow. This project is dependent upon growth in Growth Zones 1 and 2.

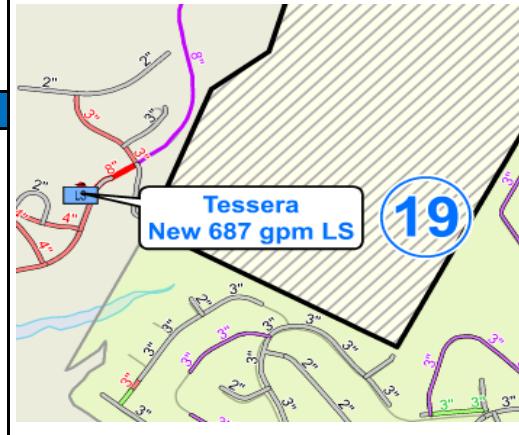
Vicinity Map

This project includes a replacement of pumps at the existing Tessera LS to improve the pumping capacity to 687 gpm.

A force main improvement from the Tessera LS is currently under design and will provide adequate capacity for the future flows from the lift station. The design flow rate will accommodate projected buildout flow. This project is dependent upon the buildout of the Tessera development. The projected capacity of this lift station will be dependent upon request for wastewater service connection within the ETJ, should an expansion of the ETJ and CCN be considered.

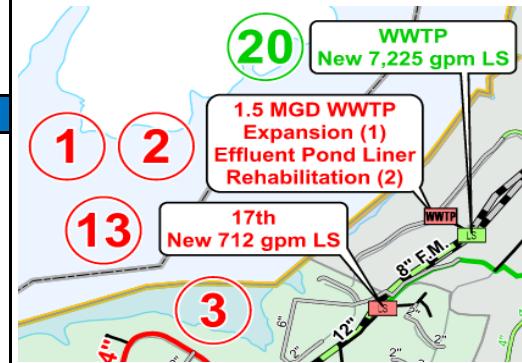
A newly constructed wet well, pumps, and piping are required to accommodate future projected buildout peak wet weather flows.

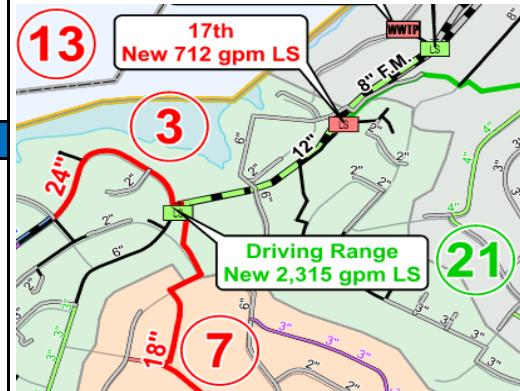
This project is required to accommodate buildout of Growth Zones 1, 2, and 4.

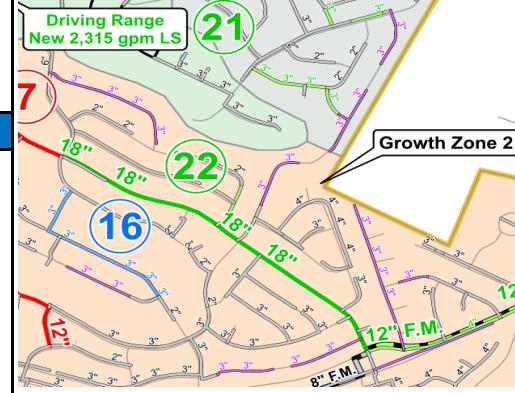
This project is dependent upon the buildout of the proposed Winn Ranch as well as the buildout of Growth Zone 4.

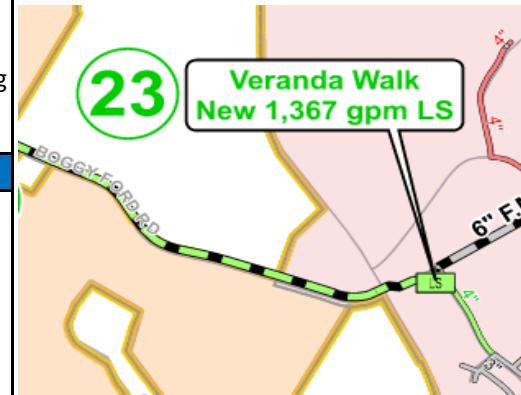
Vicinity Map

This project consists of a new 1,367 gpm Veranda Walk LS and associated 12-inch force main. The proposed 12-inch force mains disconnects local low-pressure sewer connections, so additional 3-inch and 4-inch pressure pipe will be required to reconnect existing pressure sewer customers.

This project is dependent upon the buildout of the Winn Ranch development as well as Growth Zone 4. It was assumed the Winn Ranch development sewer customers would be served by a low-pressure sewer system. Should the development be served by a gravity sewer system, the future capacity of the proposed Veranda Walk improvement should be increased to accommodate additional foul flow from wet weather events.

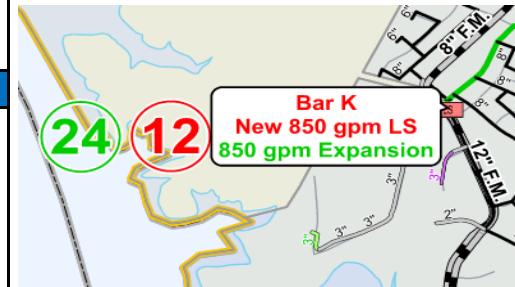
This lift station expansion is necessary to accommodate peak flows generated from the buildout of Growth Zones 7 and 8.

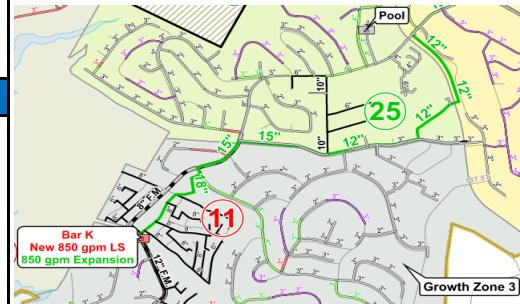
This project is largely dependent upon the buildout of Growth Zone 8. This project may be split into two segments, should Growth Zone 7 build out quicker than Growth Zone 8.

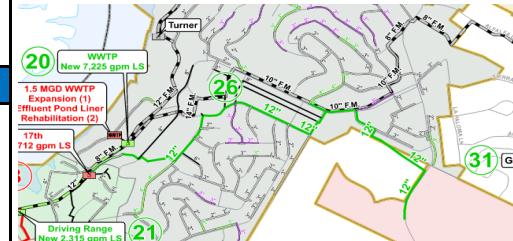
Vicinity Map

This project includes segments of 18-inch and 12-inch gravity sewer lines beginning at Lohmans Ford Road and ending at the 17th.

This project is dependent upon the buildout of the proposed Villas at Keegans Crossing as well as the development of the 140-acre parcel across the street from the proposed development.

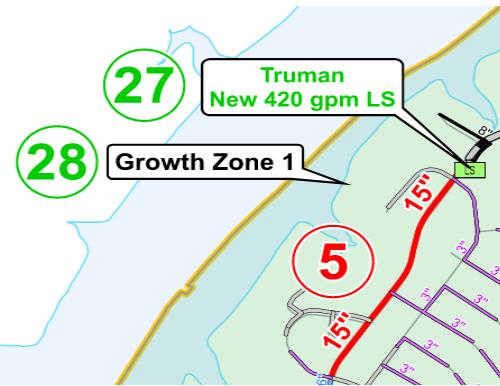
This project consists of the replacement pumps at Truman LS to bring the capacity of the lift station to 420 gpm.

This improvement is necessary as peak flows increase in the buildout planning period. Considerations for improvements to the wet well and piping should be made upon replacement of the pumps as the condition of the components may deteriorate until this project is required and may necessitate replacement.
